**FLEMING'S 8760 COMPLETES COMPLEX RE-ROOF AT
ALFA LAVAL FACILITY IN BROKEN ARROW**

ALFA LAVAL RE-ROOF

When Alfa Laval's 89,000 square-foot ACE plant had exhausted the useful life of its roof, the Swedish heat transfer solutions company called on Fleming 8760 to help. Made up of nine different building units with varying roof profiles, slopes and interior gutters, the complex project required tying all of the profiles together into a single roof plane.

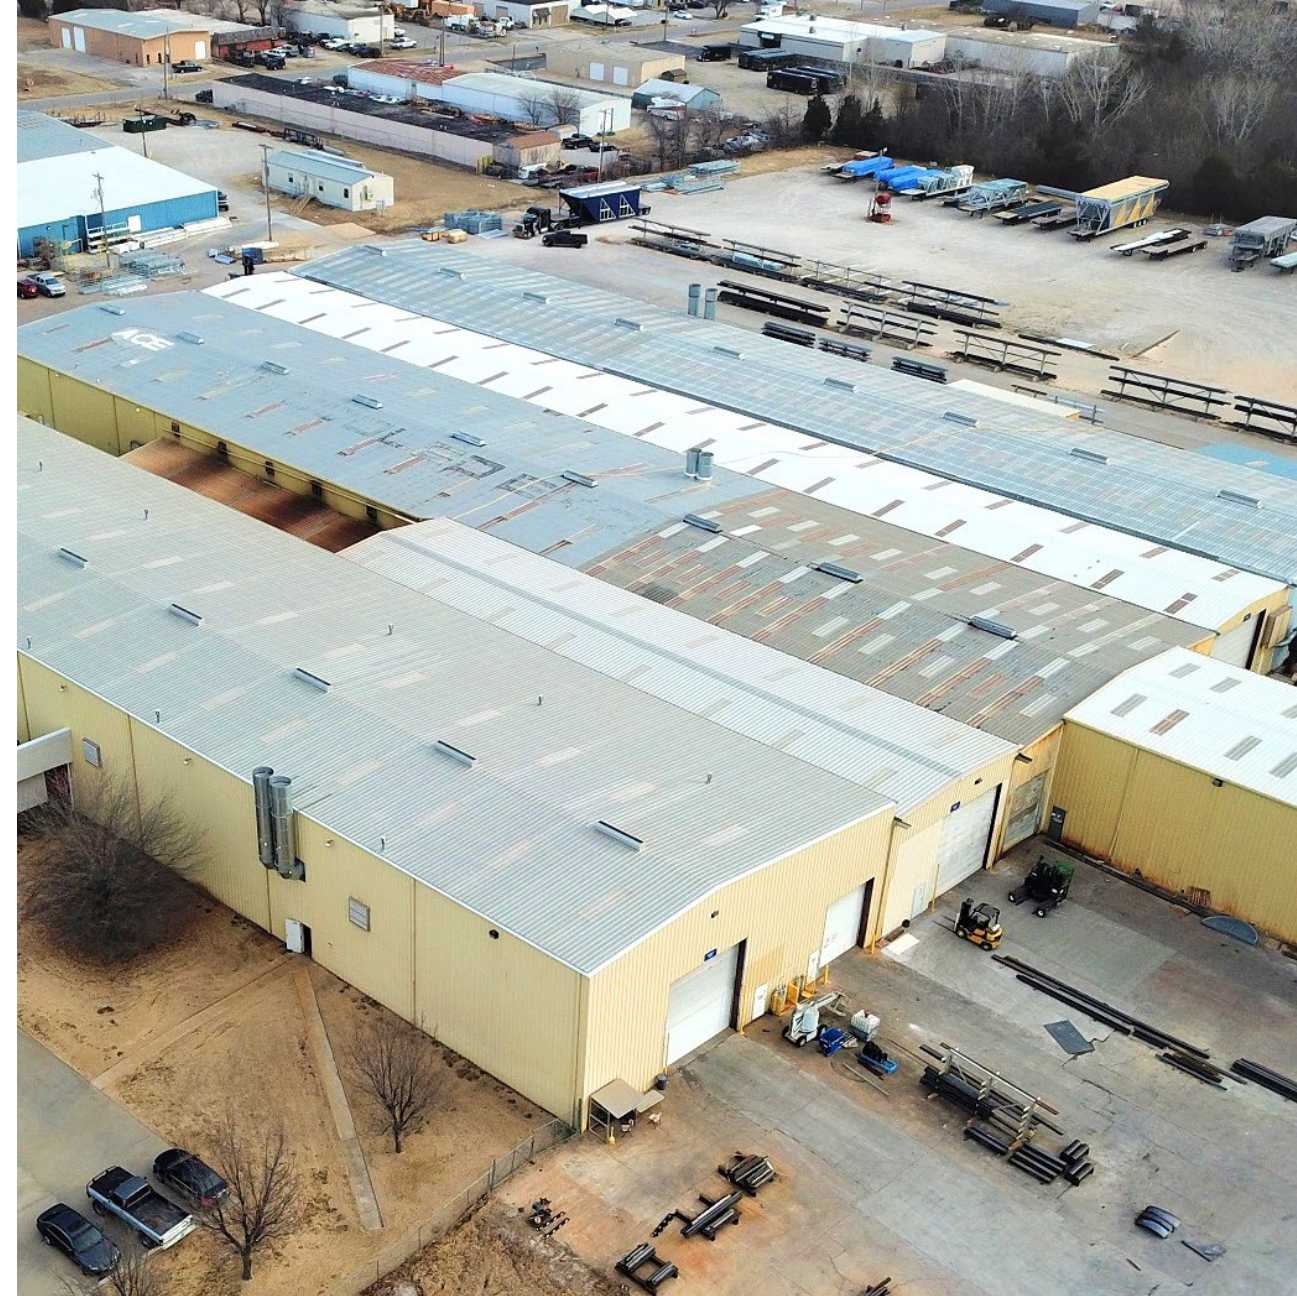
Fleming 8760 designed, supplied, and installed a Slope-Build-Up system featuring Butler's MR24 standing seam roof system. This system eliminates repair and maintenance headaches, while improving both the function and appearance of the buildings. Fleming 8760 also reverse engineered the project to maximize all applicable federal tax deductions, considerably offsetting the initial capital outlay.

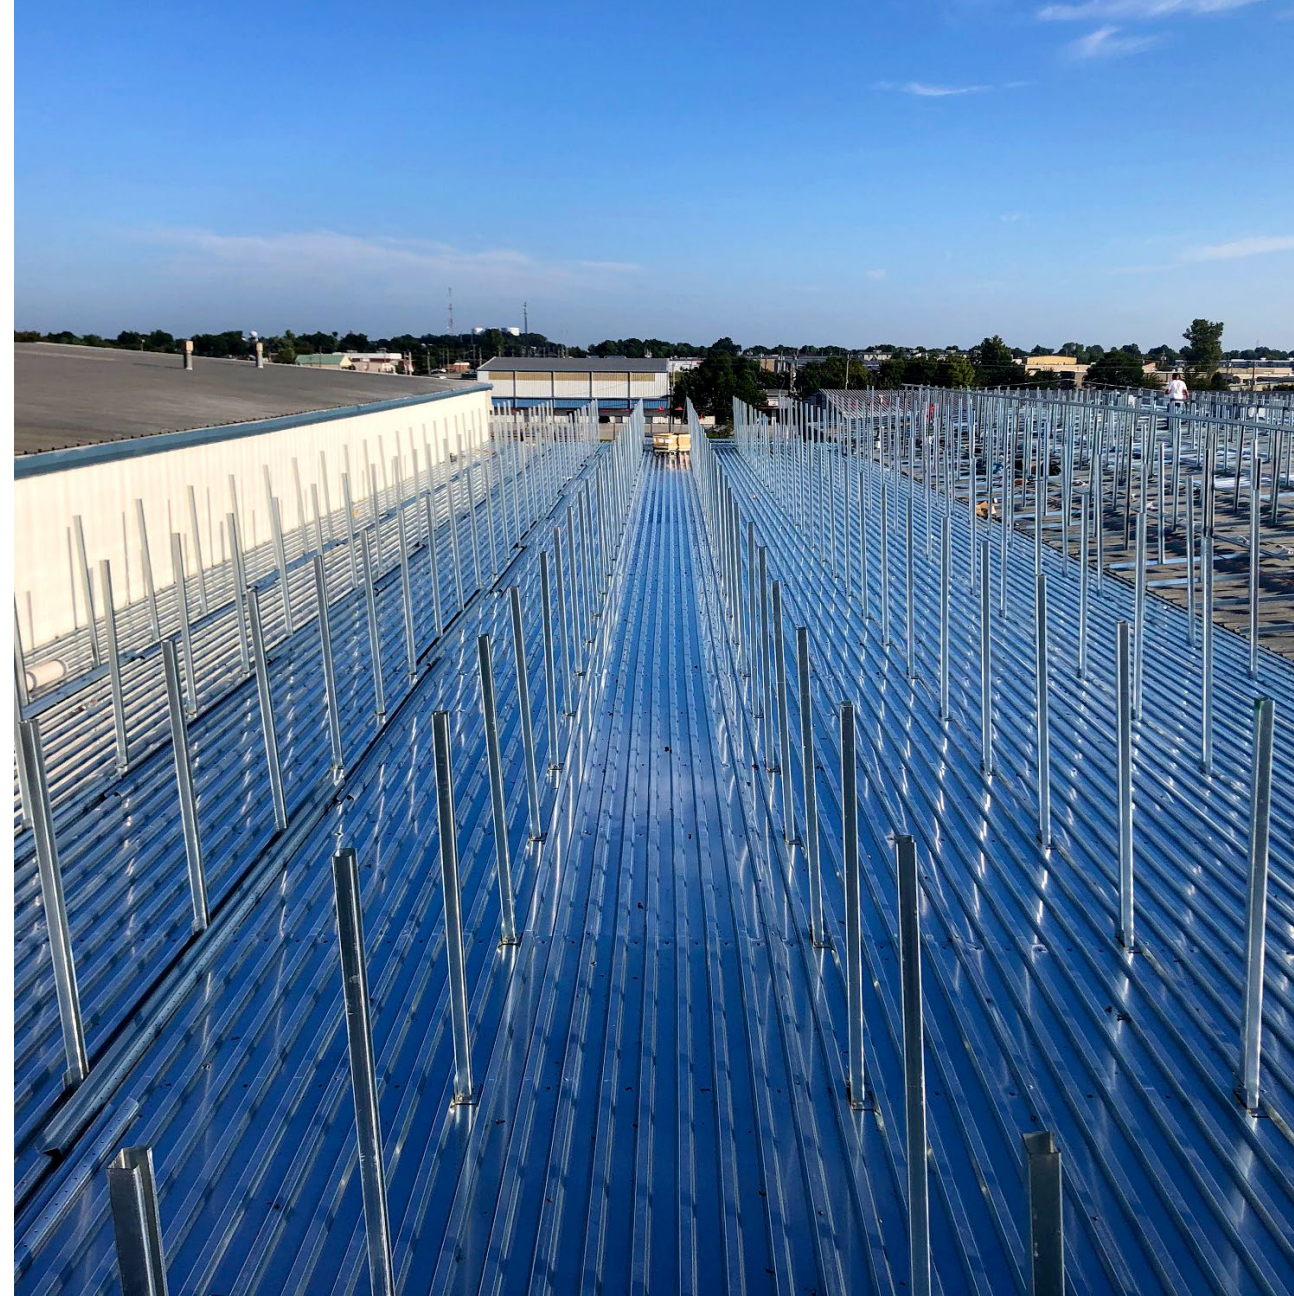
When Alfa Laval's 89,000 square-foot ACE plant had exhausted the useful life of its roof, the Swedish heat transfer solutions company called on Fleming 8760 to help.

"As the before and after images show, there was a lot going on with the existing roof system. Tying all of the various profiles together really streamlined the look of the roof and greatly improved its functionality. Eliminating all of the excess gutters and slopes reduces water entry points and the maintenance associated with keeping them in protective condition. This project definitely demonstrates 8760's capabilities as a re-roof partner for complicated projects."

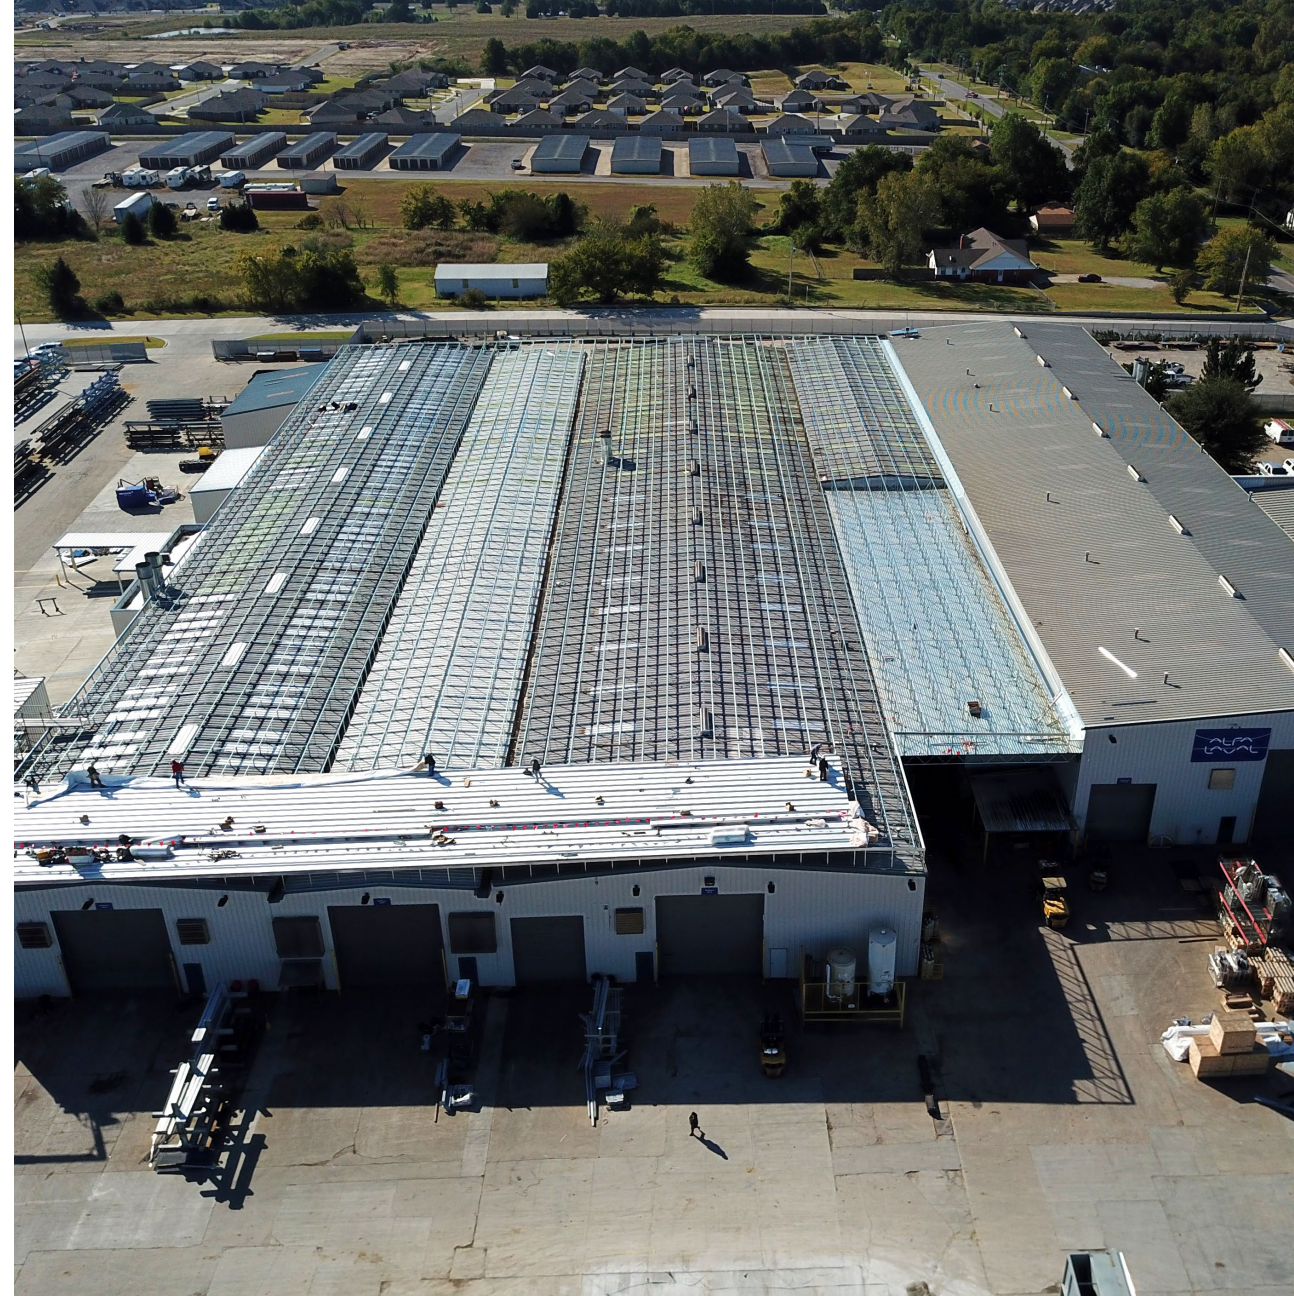
- Reinforcement of the Existing Structure
- Installation of Joist and Deck Section to Span an Open Area Between Buildings
- Elimination of Multiple Interior Roof Drains
- Leveling Out 18 Different Roof Pitches Using Butler's MR24 Patented System
